The Mycenaean Entrance System at the West End of the Akropolis of Athens

James C. Wright

Wright, James C. 1994. The Mycenaean Entrance System at the West End of the Akropolis of Athens. *Hesperia* 63:323-360.

THE MYCENAEAN ENTRANCE SYSTEM AT THE WEST END OF THE AKROPOLIS OF ATHENS

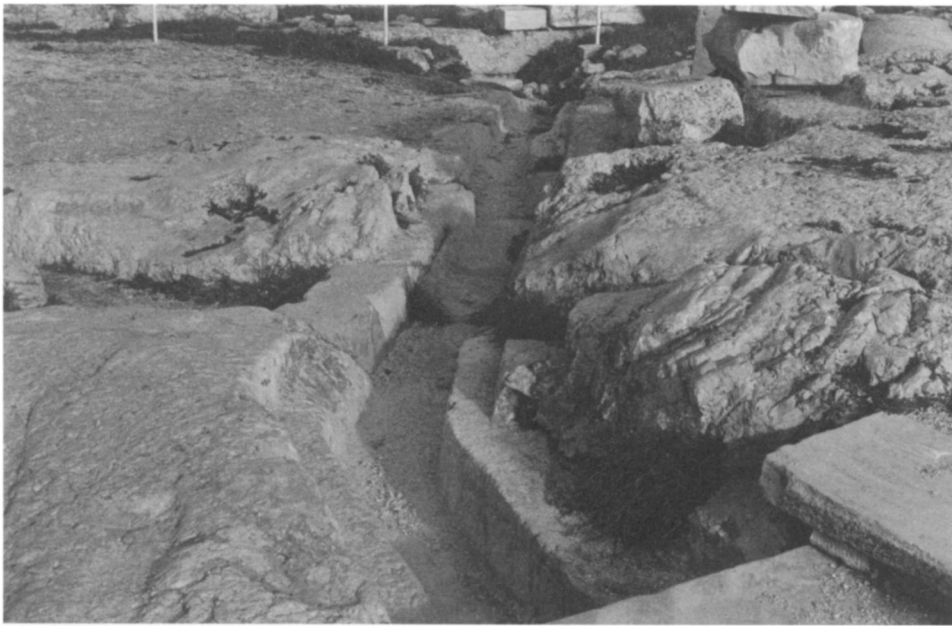
a. Drain cutting leading from the east porch of the Propylaia towards the Archaic cistern.
From south

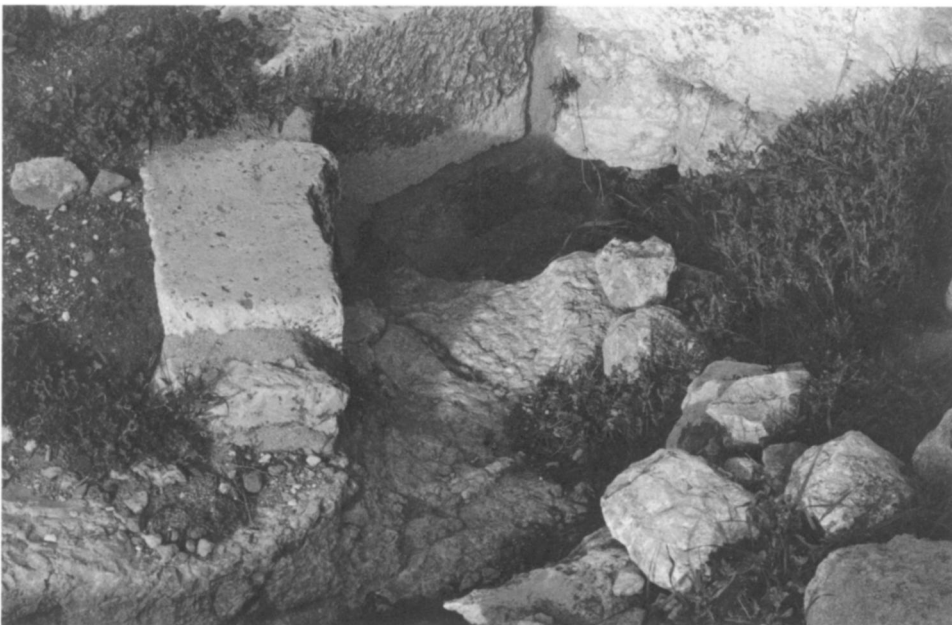
b. Drain leading into the Archaic cistern, north face

The northwest corner is the natural collection point for the drainage of the Akropolis. The lowest surface in this area (*ca.* +137 m.) is directly over the caves of the North Slope; indeed, the continuous runoff of water there over the millennia has caused the hollowing out of these caves. Approaching this area is a drain cut into the rock in front of the east façade of the Propylaea. It continues northwards to the Northwest Building (Fig. 10, Pl. 77:a) and is the original drain that led to the Archaic cistern.¹¹¹ This drain can be identified by a reveal cut into the bedrock on each side of the upper drain walls to receive cover slabs, now missing. A second, later channel forks to the northwest from the primary one (see p. 357 below). At the north end the original course has been marred by erosion and damage to the rock face, perhaps due partly to making the foundation bedding for the southern wall (Figs. 10, 11: wall 8) of the Northwest Building. Close examination shows that the drain ran under this wall into the Archaic cistern (Pl. 77:b).

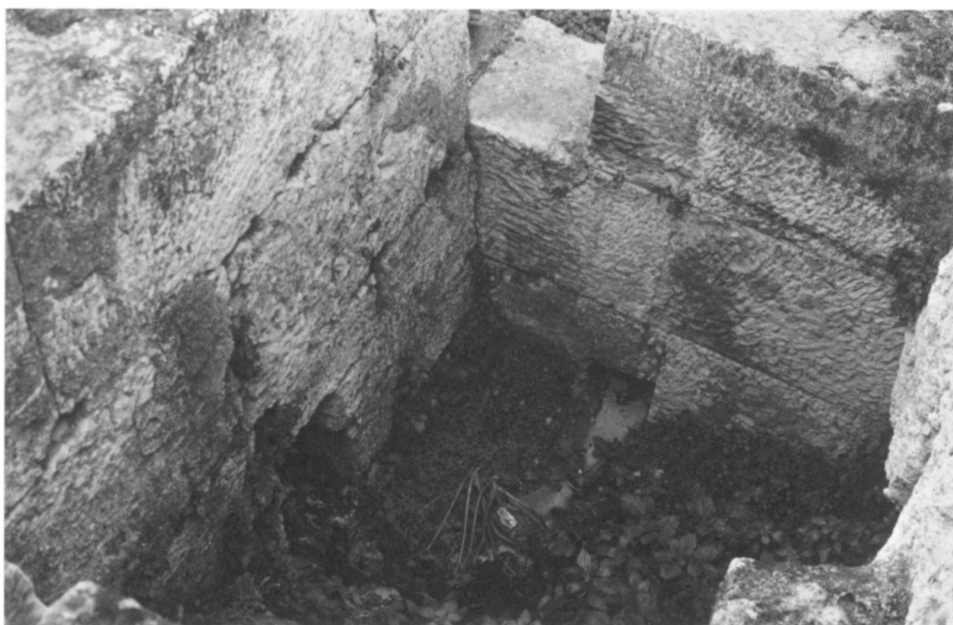
b. Drain channel in north wall 2 (right) and crosswall 3 of the Archaic cistern. From south

the bedrock on the other side of the central east–west foundation of the Northwest Building. This wall is built like walls 1 and 2. Like the northern wall it has a channel cut through the lowest course (Pls. 78:b, 79:a). In this channel Kawerau reported finding two marble tiles set together to form a kind of drain.¹¹⁷

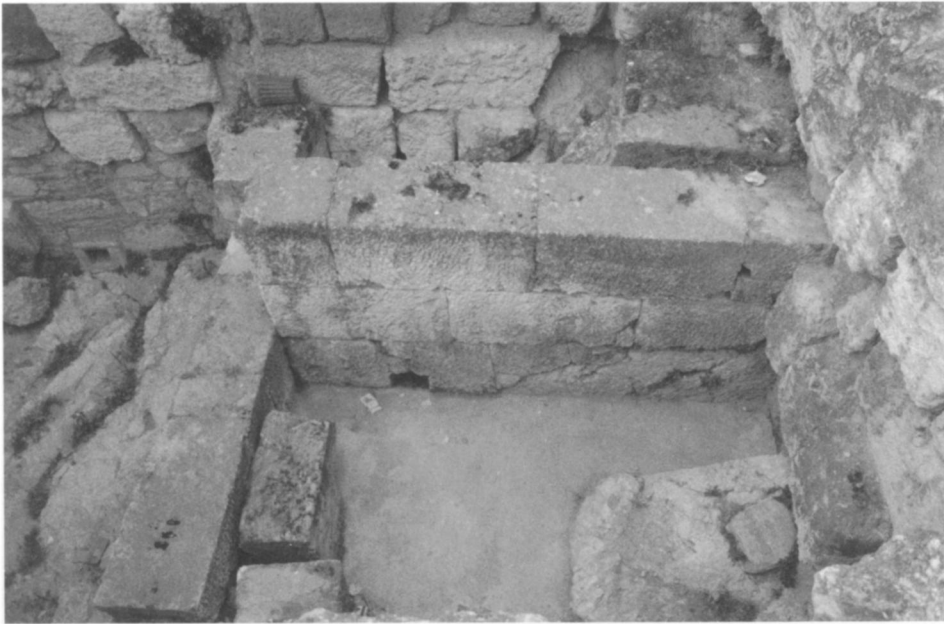
a. North-south crosswall 3 of the Archaic cistern. From west

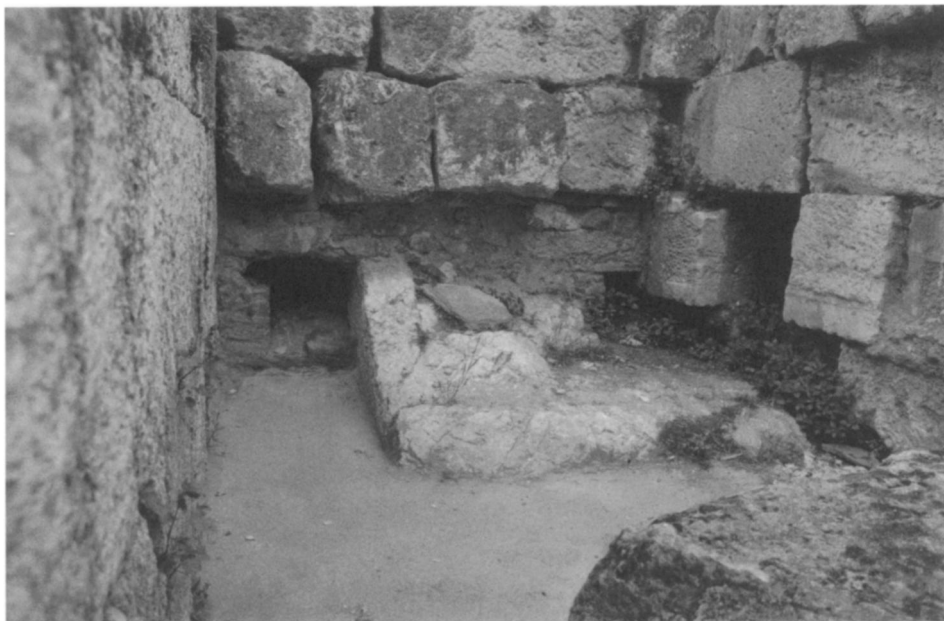
b. Later drains and worked bedrock in the northwest room of the Archaic cistern. From north

¹¹⁶ A late (Byzantine? Turkish?) drainage system was cut through the lowest foundation courses of the east–west crosswall 9 of the Northwest Building (Pl. 80:c) and then turned to the west, where another hole was mined through the west foundation 14 of the Northwest Building, presumably to link the drain with either the Roman cistern or the Classical drain. These constructions are easily recognized today by the use of tiles and cement to help support them under the foundations and, probably, by crude cuttings in the bedrock apparently following the course of the drain (visible as the hatched bedrock corner between walls 9 and 14 in Kawerau’s sketch, reproduced here as Figure 11, and in Plate 79:a). This area may have been partially excavated in 1864 (Bundgård 1974a, p. 9), which may explain why Kawerau was unable to make any stratigraphic notes when work continued in this area in 1886 (cf. Bundgård 1974a, p. 12).

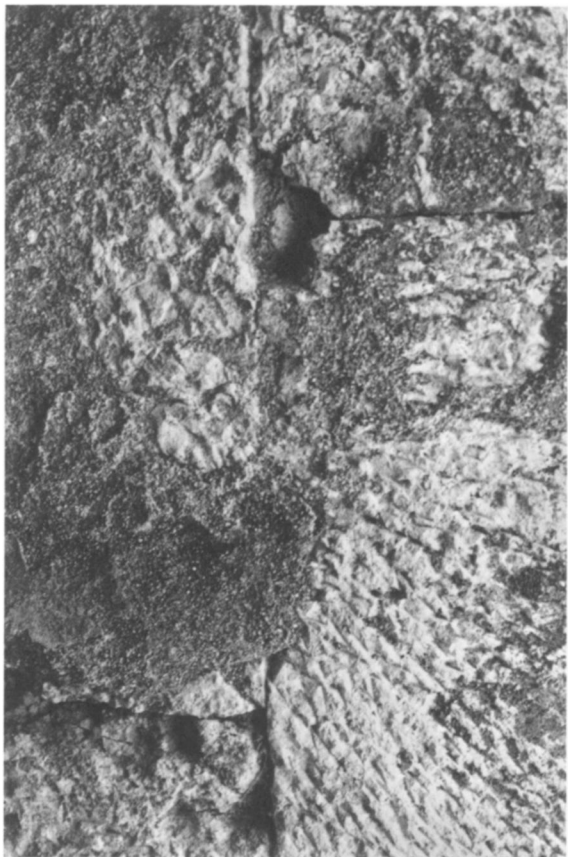
b. Detail of plaster adhering to the cistern wall

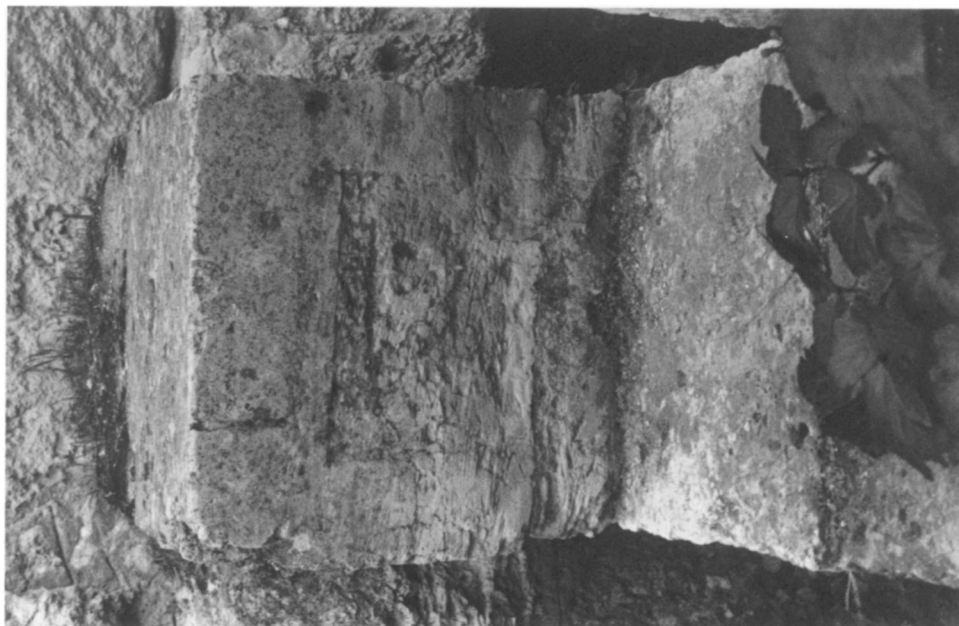
a. Anathyrosis on block of north wall 2 of the Archaic cistern. From west
